BACHO V. ROUGH COUNTRY, LLC. ET AL

CASE NO: 13-564

Prepared for: Tom Willingham

Report date: August 27, 2014

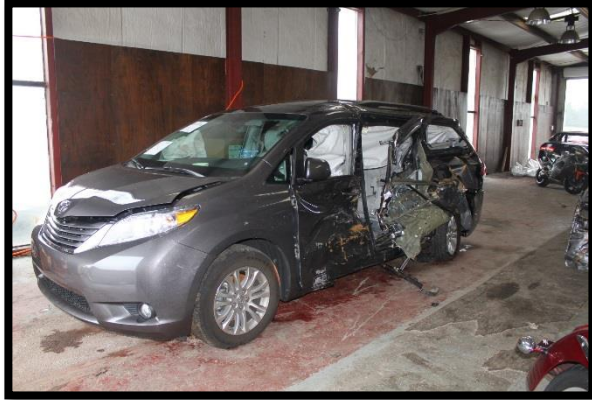
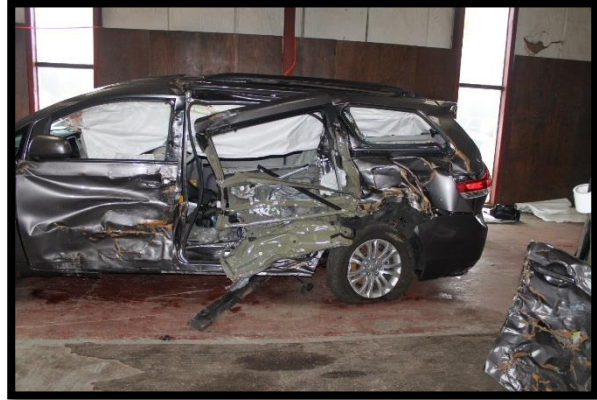
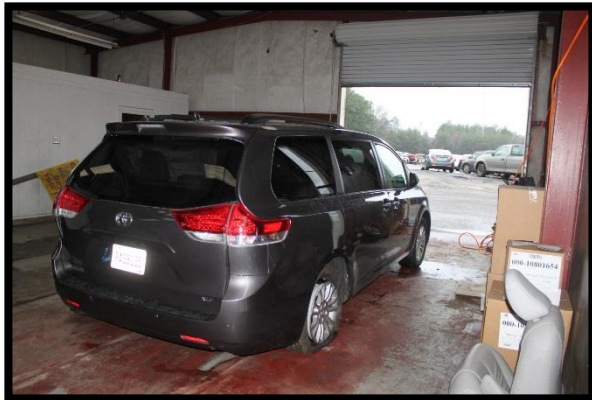
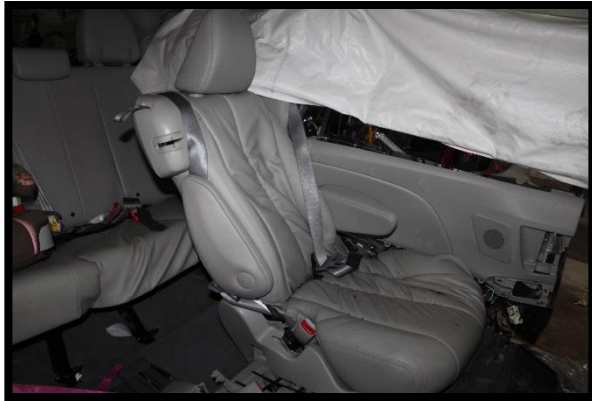
3. **Photographs of the Toyota and Chevrolet taken by Steve Gray show deformation profile to both vehicles:**

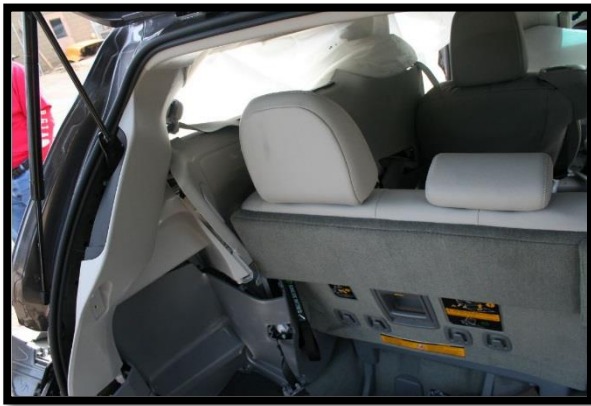
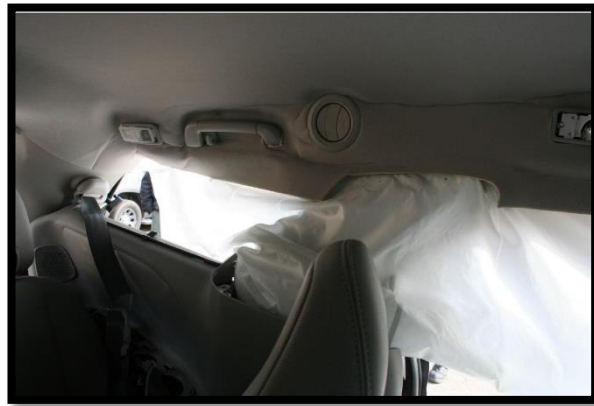
The following two police photographs are included to show that there is no obvious blood in and around Abigail's seated position or on the side airbag.

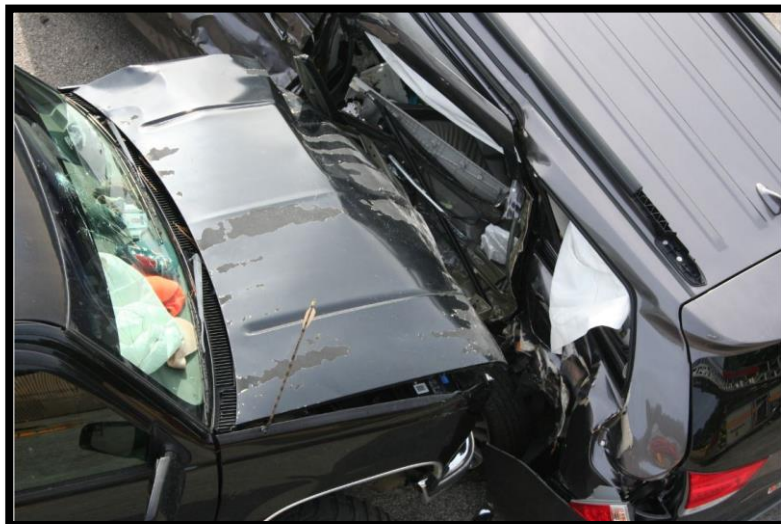
The following photographs were taken by the police when they lined up the Chevrolet and the Toyota. It is noted that this is a static recreation and the dynamic crush would have been greater.

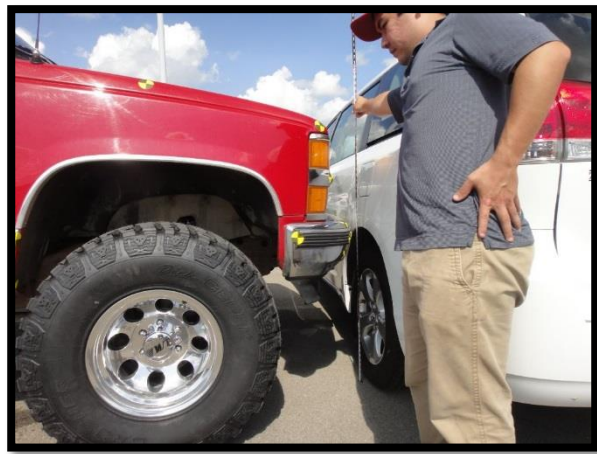
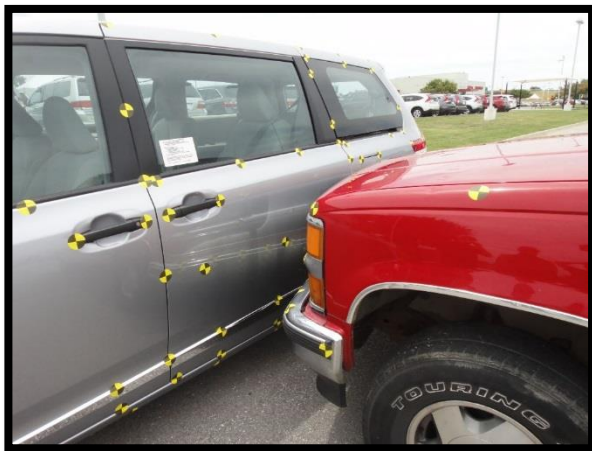
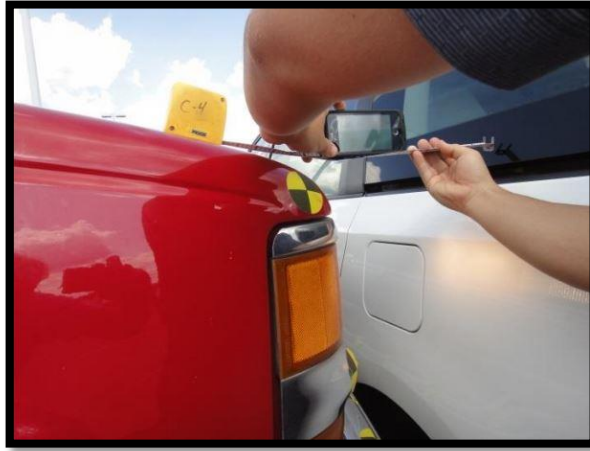
Renfro Engineering aligned exemplar vehicles to show the height differential between an OEM Chevrolet and a Chevrolet with a lift kit.

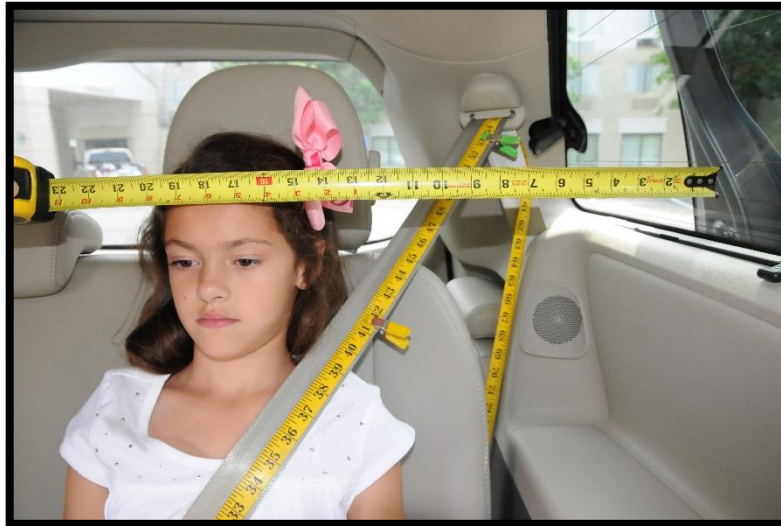
7078- In this position the center of her forehead was approximately 18 inches from the plane of her nearside window.

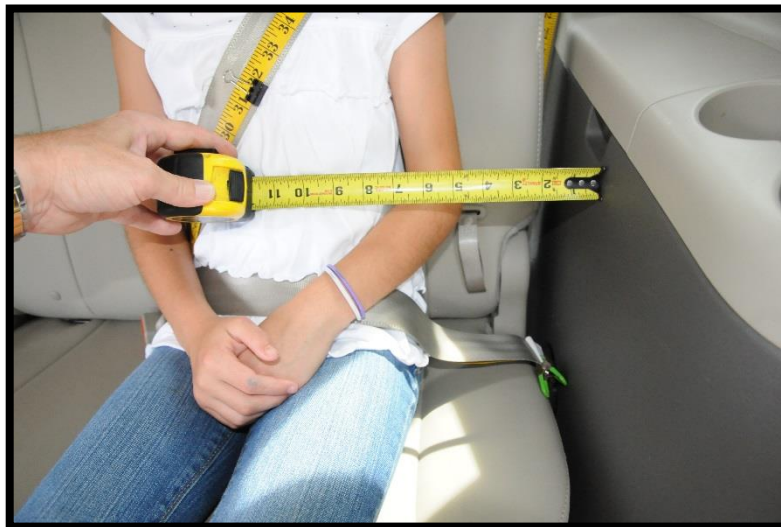
7089- In this same position the center of her torso/abdomen was approximately 11 inches away and her left hip approximately 6 inches away from her near side vehicle structures.

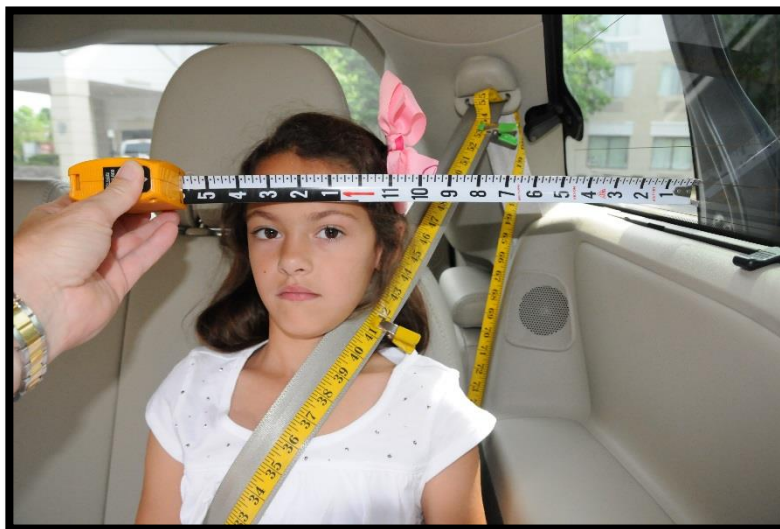
7093- In this position the center of her forehead was approximately 14 inches away from the plane of her nearside window and the left side of her head approximately 10 inches away from the interior panel.

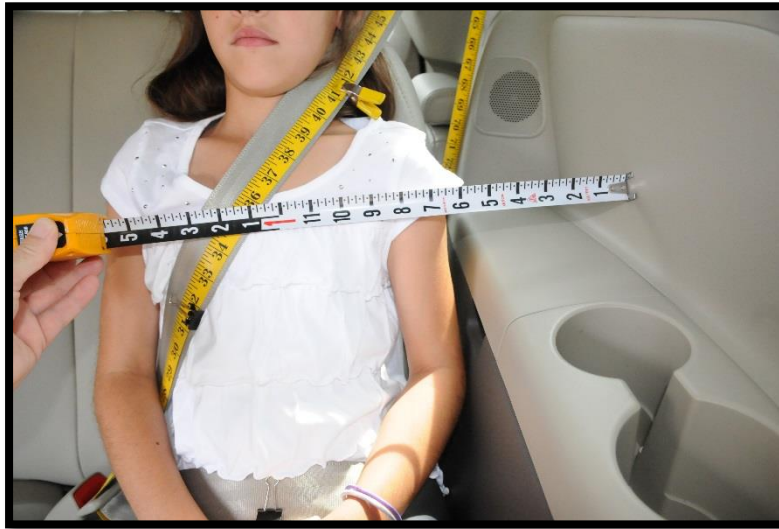
7095- In this same position the center of her torso/abdomen was approximately 12 inches away from her near side vehicle structures.

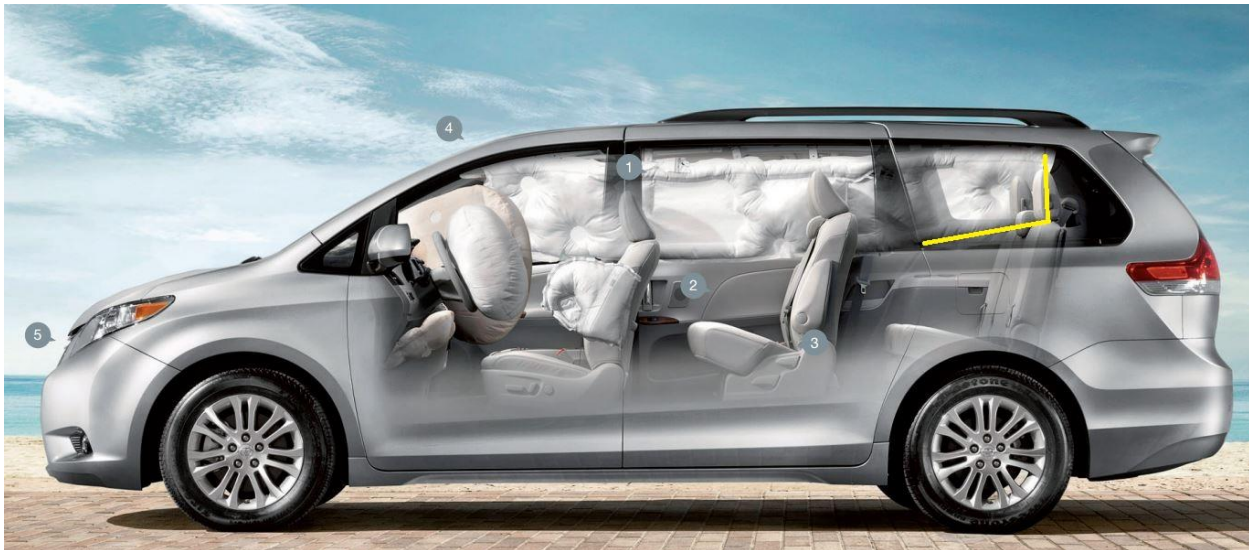
7. Side curtain airbag coverage in the Sienna

The following image is taken from Toyota's brochure for the Sienna and shows the area of side curtain airbag coverage. The yellow line has been drawn in the rear window to indicate the area of airbag coverage for Abigail's position.

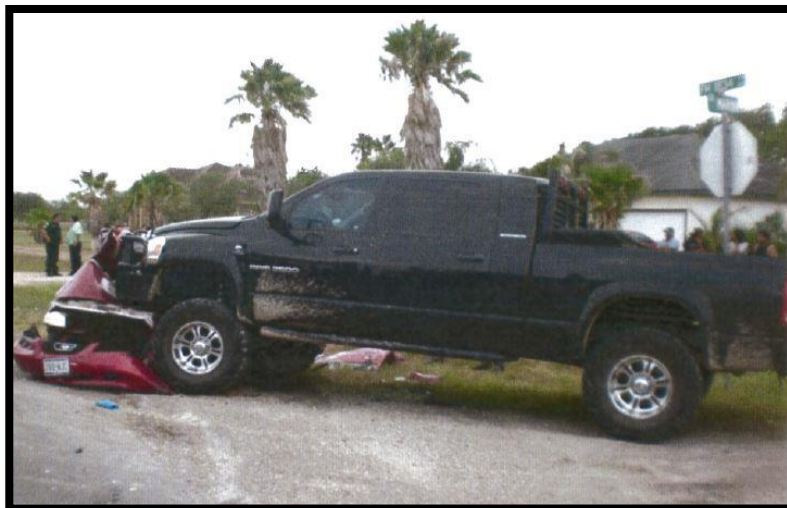
Accident scene photograph

I was involved as a biomedical expert in a case involving a Rough Country lift kit. A 2006 Dodge Ram truck equipped with the lift kit impacted a 1999 Ford Mustang in the left front. The driver's head was impacted by the truck's bumper causing her skull fractures, traumatic brain injury, and permanent impairment.

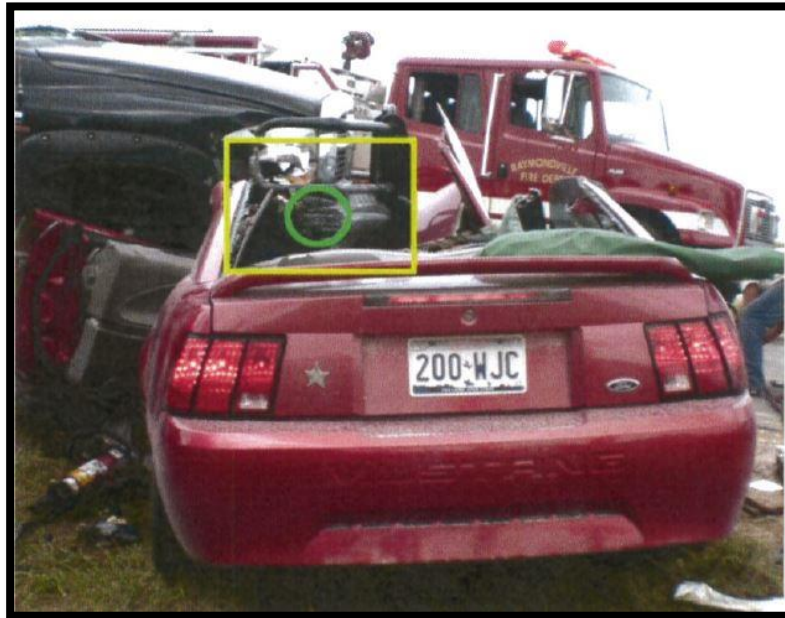
Accident scene photograph with the yellow box indicating the area of the Dodge's bumper that has intruded into the Mustang's occupant space and the green circle indicates the area where the driver's head was approximately located.

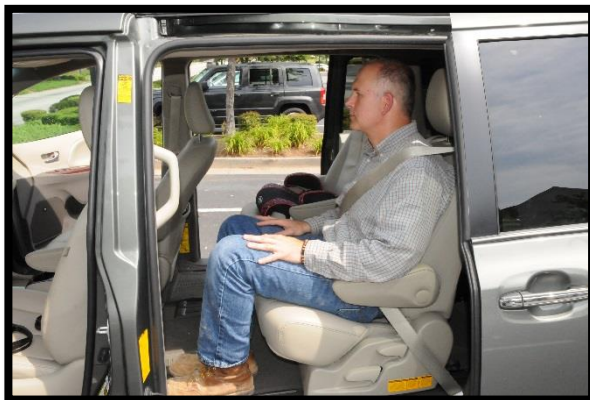
7147 and 7149

- 1.6 I had the opportunity during my surrogate study to place Mr. Bacho in the exemplar Sienna. Mr. Bacho is 6' tall and 190 pounds. The two photographs of him below illustrate the location of his head in reference to the roof and pillar structures and door verses the third picture of the surrogate which illustrates the difference in how much significantly lower Abigail's head would have been. His head is located in the protective confines of the side curtain airbag as evidenced by his injury profile of chest, abdominal, and lower extremity injuries due to his stature. His lower body is located in the area of the intruding Chevrolet that would have had greater intrusion but for the interaction with the C pillar and side door beams that were not present at Abigail's position.

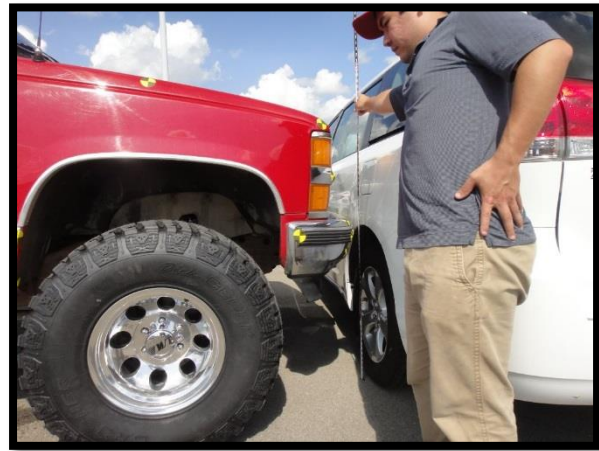
- 3.6 This compatibility is demonstrated in Dr. Renfroe's exemplar photographs. The below picture on the left shows that without the lift kit, the Chevrolet's bumper would engage the wheel and tire and wheel well area well below the top of the wheel well and the other frontal structures such as the hood engage with the Toyota well below the rear window area where Abigail was seated. The picture on the right shows that when the Chevrolet has a lift kit it's bumper engages the Toyota at the top of the wheel well, missing any resistance from the wheel and tire and the other stiffer frontal structures of the truck engage the vehicle in an area that is effectively just sheet metal that is less significantly stiff.
